GADSDEN INDEPENDENT SCHOOL DISTRICT

PAVEMENT ANALYSIS REPORT

RIVERSIDE, SUNLAND PARK, DESERT VIEW

FEBRUARY 8, 2012

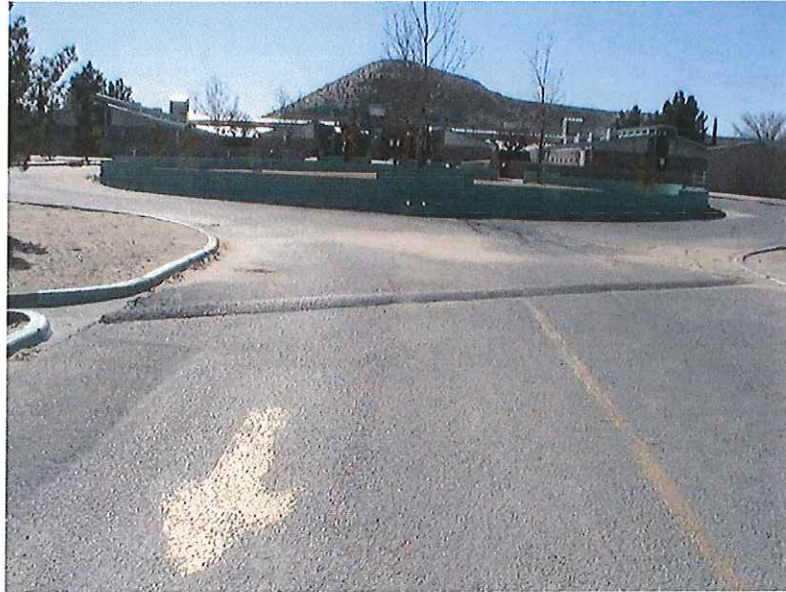
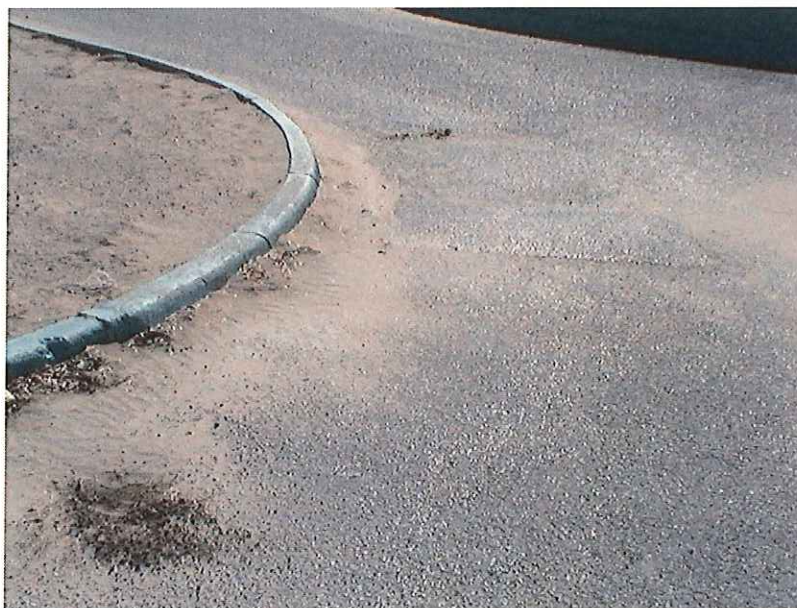
Figure 2 - Desert View Elementary Main Circle Drive

The main circle drive entrance to Desert View appears to be part of the original construction of the school building and is showing signs of disintegration and wear. Raveling and weathering of the pavement is evident by a rough jagged pavement surface. Pavement aggregate polishing is also apparent and is due to prolonged traffic use over the surface. The turn out to Valle Vista Dr. shows the most extensive surface damage with various potholes and repairs. This portion of asphalt paving has reached the extent of its expected useful life and will require complete removal and replacement of the asphalt surface.

- Main Circle Drive Entrance – Poor Condition - Complete removal and replacement of asphalt surface 2 to 4 years.
Complete Asphalt Removal & Replacement \$78,000
- Faculty and Parent / Visitor Parking – Fair Condition – 1" asphalt surface overlay or crack repair and pavement preservation slurry sealer 2 to 4 years.
1" Asphalt Overlay \$7,500 each (X2)
Crack Repair & Pavement Preservation Slurry treatment \$3,500 each (X2)
- Bus Drop Off – Good Condition - pavement preservation slurry within 6 to 8 years.
Pavement Preservation Slurry Treatment \$2,000
- Student Drop Off – Good Condition – pavement preservation slurry within 6 to 8 years.

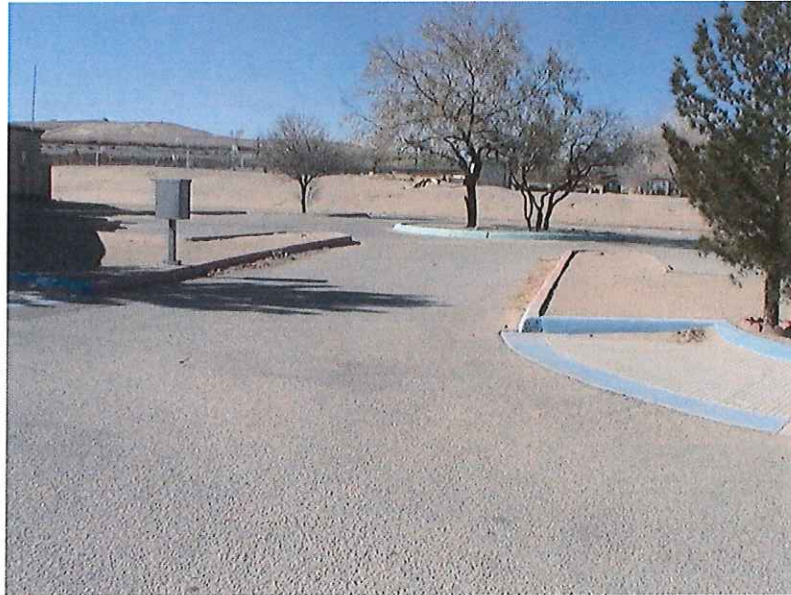
Figure 4 - Desert View Faculty Parking

The Faculty and Parent/Visitor parking lots east and west of the circle drive show less wear than the main circle drive, but do exhibit signs of raveling and weathering. Much of the asphalt binder has been lost over the years and reveals a rough aggregate finish. Typically these two parking areas only experience light vehicle traffic with only limited heavy truck traffic. A 1" asphalt surface overlay would extend the useful life cycle by 8 to 10 years or a crack repair and a pavement preservation slurry seal treatment could be used to extend it 6 to 8 years. The 1" asphalt surface overlay would provide extended useful life and overall

improved performance. However the crack repair and pavement preservation treatment would be recommended as a minimum maintenance objective.

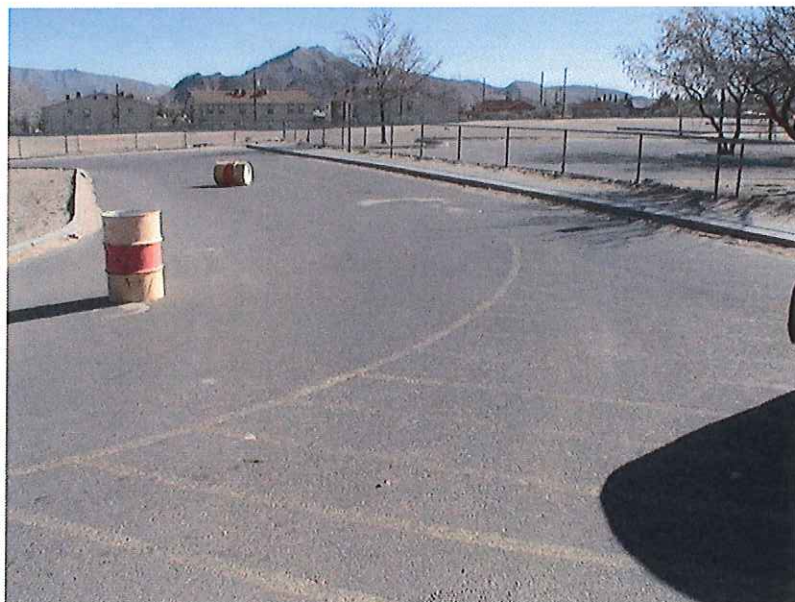
Figure 5 - Desert View Bus Drop Off

The bus drop off to the east of the main circle drive is relatively new and is in good condition. Removal of the accumulation of sand and debris from the concrete gutter pans is needed and a regular schedule of general sweeping and cleaning of all drainage paths should be implemented in the school maintenance program. A pavement preservation slurry treatment within the next 6 to 8 years is recommended.

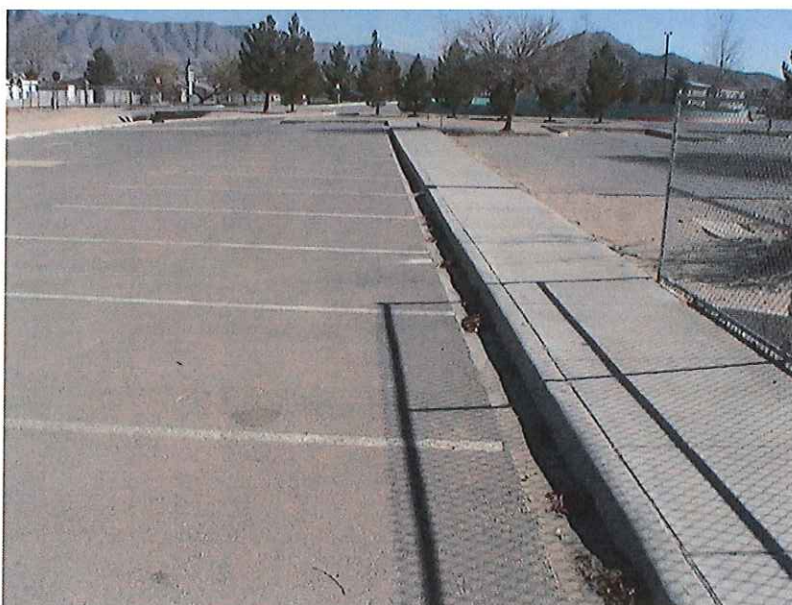
Figure 6 - Desert View Parent Student Drop Off

The student drop off on the west side is also new and in good condition. Typical sand and debris removal along the gutter pans and drainage paths is also recommended. A pavement preservation slurry treatment within the next 6 to 8 years will extend the pavement life cycle. Associated curb and gutters, sidewalks, ramps and drainage structures appeared in good condition and only regular cleaning is required. New striping and marking will be required after any pavement preservation treatment is completed.

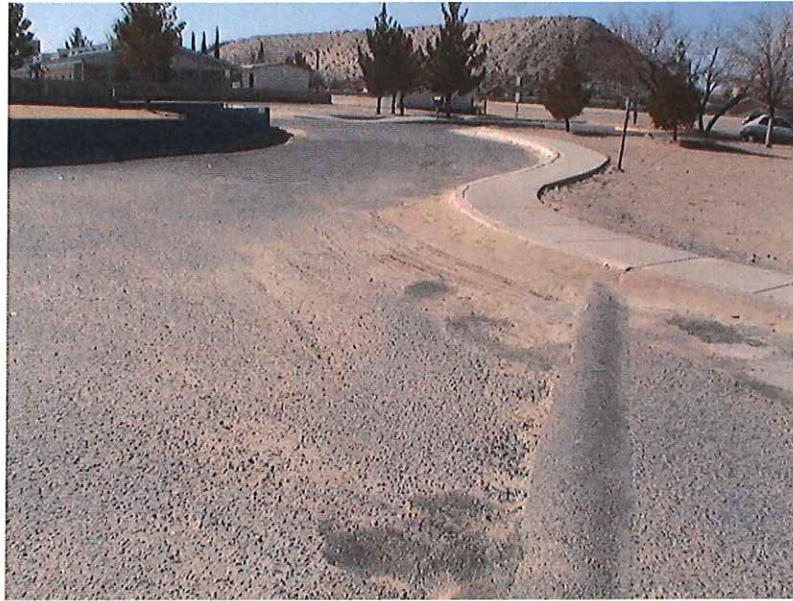
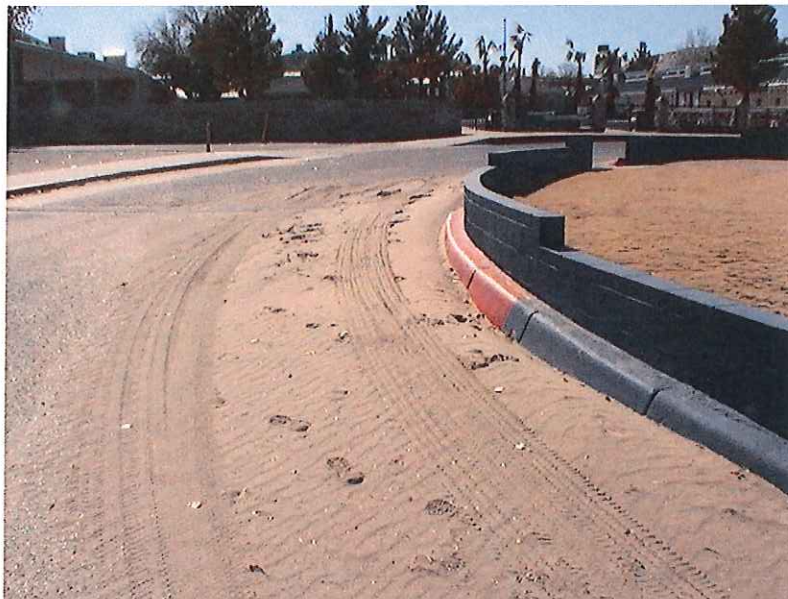
Figure 8 - Sunland Park ES Main Circle Drive

The Main Circle Drive entrance is in poor condition and is weathered and raveled extensively. Many pothole and patches are apparent throughout the driving surface, as are ruts and large deposits of fine sand particles and debris. A pavement section located at the main entrance, from Alto Vista Drive to the apparent right of way will require complete removal and replacement as soon as funding allows.

- Main Circle Drive – Poor Condition – Complete pavement removal and replacement within the next 2 to 4 years.

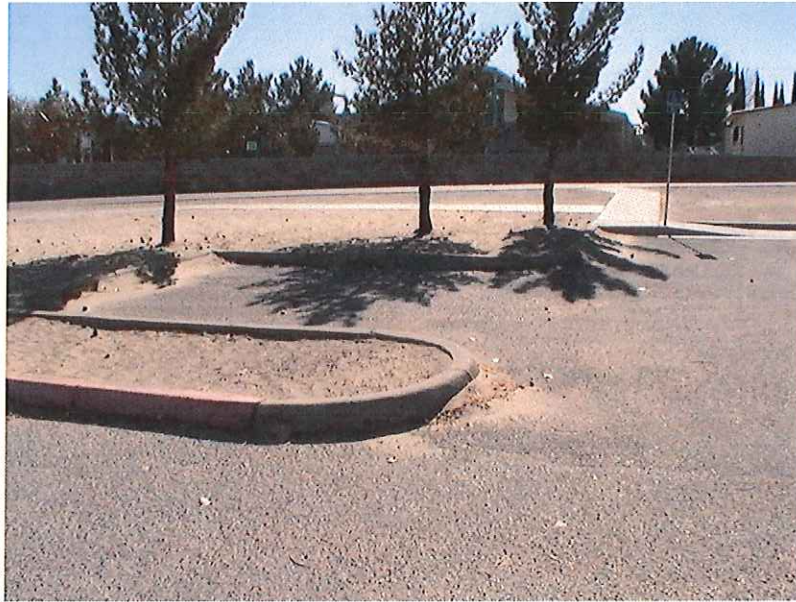
Figure 10 - Sunland Park ES Parent / Visitor Parking

The Parent/ Visitor parking to the east is also weathered and has lost a major portion of binder material which has left portions of the aggregate exposed. There were no signs of major cracking or asphalt displacement, which would indicate the underlying substrate material is in good condition. Due to the relative light traffic this parking lot experiences, a complete removal and replacement could be delayed by a 1" asphalt surface overlay or pavement preservation slurry treatment. As with the other schools, the 1" overlay option would greatly extend the service life of the parking lot, but may not be financially feasible

within the next 2 to 4 years. At a minimum, the pavement preservation treatment should be scheduled within the next 2 to 4 years.

- Parent / Visitor Parking – Fair Condition – Pavement preservation slurry seal or 1" asphalt overlay within 2 to 4 years.

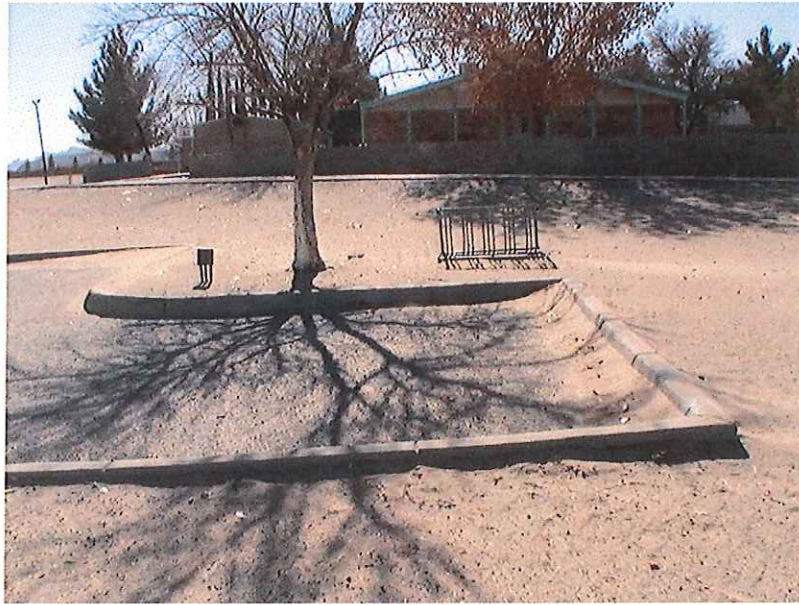
Figure 11 - Sunland Park ES Faculty Parking

The Faculty parking area west of the circle drive also appears to be original to the school building and appears to experience much of the same wear that the parent / visitor parking area has. The binder material has disintegrated over the years and left a rough pavement surface. There are some areas of pothole patches, but no major longitudinal cracking is evident. With a general sand and debris removal program implemented, the expected useful life can be extended with a pavement preservation slurry applied within the next 4 to 6 years. The expansion of the faculty parking area that was complete in 2004 is in good condition and no immediate action is required. Pavement preservation slurry should be scheduled within the next 8 to 10 years.

- Faculty Parking – Fair Condition- Pavement preservation slurry treatment or 1" asphalt surface overlay within 4 to 6 years.

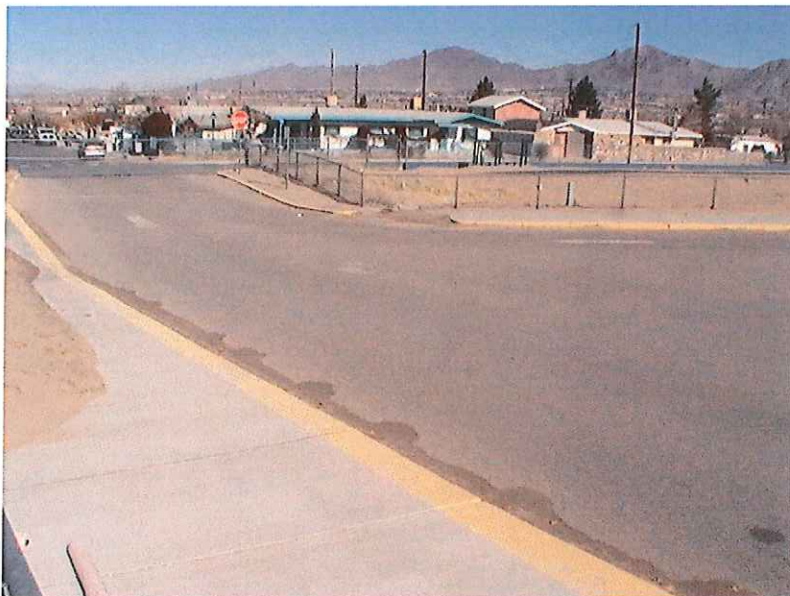
Figure 12 - Sunland Park ES Bus Drop Off

The separate Bus Drop Off east of the main entrance is in good condition, with the exception of accumulation of fine sand particles. General pavement sweeping of the top surface and along the curb line will allow for appropriate drainage flow patterns and improve general appearance. A pavement preservation treatment should be scheduled within the next 6 to 8 years to extend the pavement performance.

- Bus Drop Off – Good Condition – Pavement preservation slurry seal within 6 to 8 years.

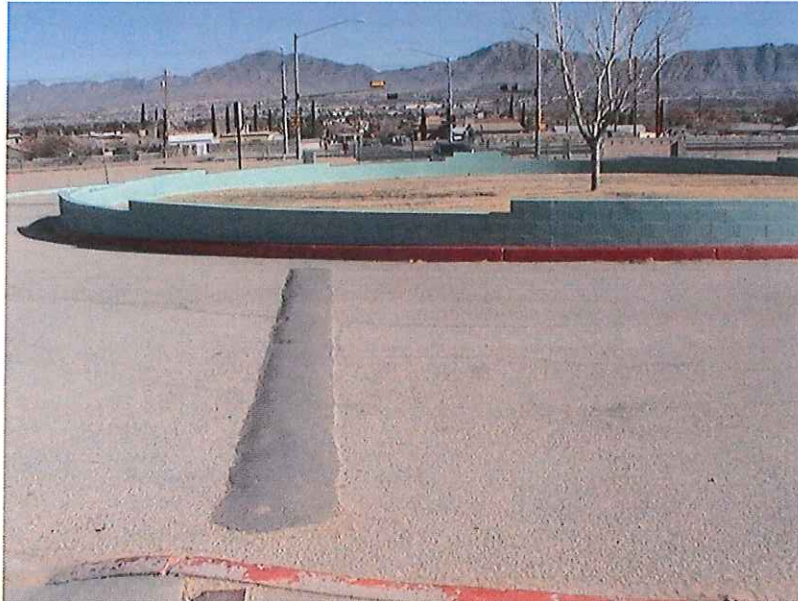
Figure 14 - Riverside ES Main Circle Drive

The Main Circle Drive entrance pavement surface is deteriorated and has many potholes and large areas of pavement patches throughout. Longitudinal cracks are prevalent throughout the circle drive as well loss of much of the asphalt binder material. The entrance to the circle drive should be scheduled for complete removal and replacement. Additional cost will need to be anticipated for some rework of the substrate base course material and the replacement of traffic signal sensors at the McNutt and Main Circle drive intersection. The remaining pavement surface of the Circle Drive would benefit

from a 1" asphalt surface overlay to extend the service life of the pavement. A replacement and overlay time frame would be expected to be to be completed within the next 2 to 4 years.

- Main Circle Drive – Poor Condition – Complete pavement removal and replacement within 2 to 4 years.

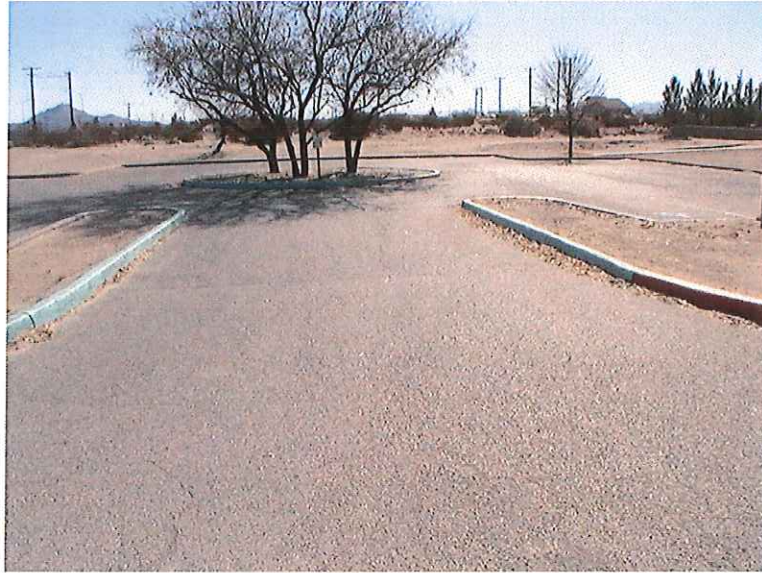
Figure 15 - Riverside ES Visitor Parking

The adjacent Visitor and Faculty parking areas are in similar condition with loss of asphalt binder material, weathering and longitudinal cracking. However, due to the limited use of these parking areas, complete removal and replacement could be delayed by a 1" asphalt surface overlay or crack sealing and pavement preservation slurry treatment. If either option is applied within the next 2 to 4 years, the complete removal and replacement could be extended by 8 to 10.

- Visitor Parking – Fair Condition - Crack repair and pavement preservation treatment or 1" asphalt overlay within 2 to 4 years.

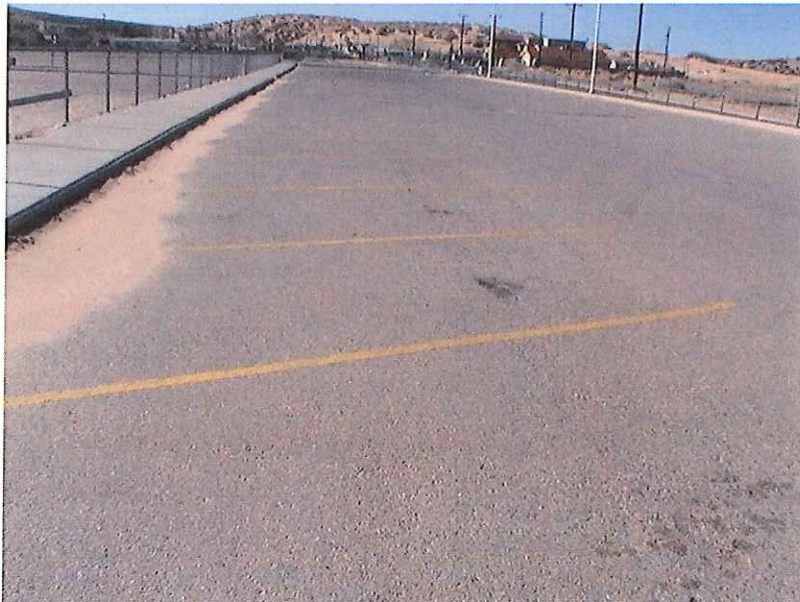
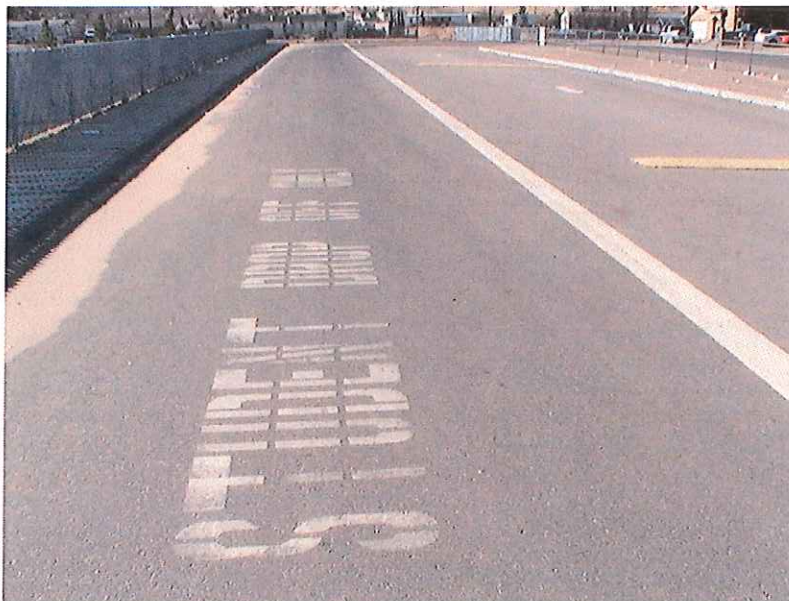
Figure 16 - Riverside ES Student Drop Off (Chama Ln.)

A new Parent / Student Drop Off was also constructed in 2006 and remains in good condition. As with the adjacent Visitor Parking area, the new Student Drop Off should be scheduled for a pavement preservation slurry treatment and restriping within the next 6 to 8 years.

- Student Drop Off (Chama Lane) – Good Condition- Pavement preservation treatment within 6 to 8 years.

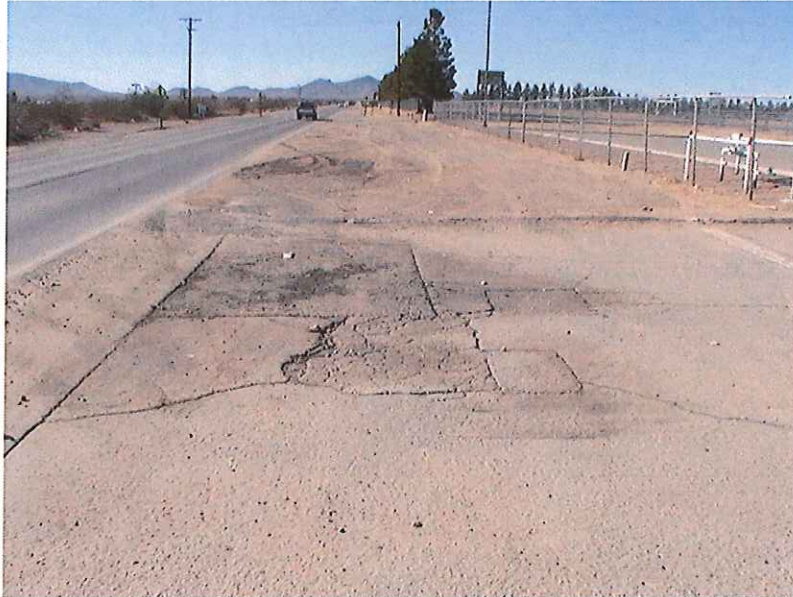
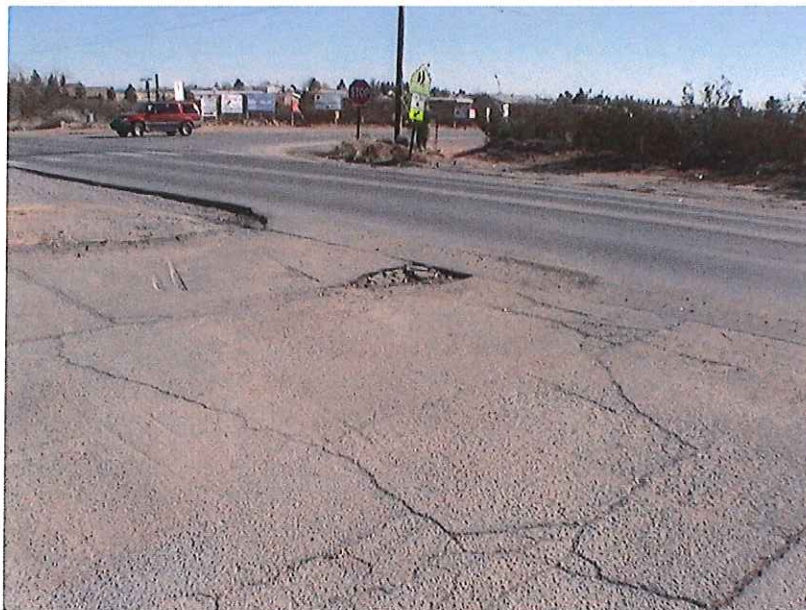
Figure 19 - Chaparral ES Main Parking Entrance

The Main parking and parent student drop off is in a dilapidated state with many longitudinal and transverse cracks throughout. As expected for the age of the asphalt pavement, much of the binder material has been lost over time and the driving surface is rough and worn with ruts and surface disintegration. The main access from Lisa Drive is in very poor condition and is in need of immediate repair. Large potholes and broken pavement sections impede traffic to and from the facility and should be a priority for complete replacement. The asphalt curb on the east end of the parking lot is broken with various sections missing in many areas along its length. Potholes and temporary repairs are also evident throughout the pavement surface. It is recommended that the entire parking surface be removed and replaced. Additional installation of curb and gutters, as well as sidewalks should be included as part of the overall project. This parking facility is generally

inadequate to handle the current volume of traffic and additional parking should be considered. The overall condition of this parking facility warrants complete removal and replacement as soon as practical for the District.

- Main Parking and Parent Student Drop Off – Poor Condition- Complete removal and Replacement including turnouts within the next 1 to 3 years.

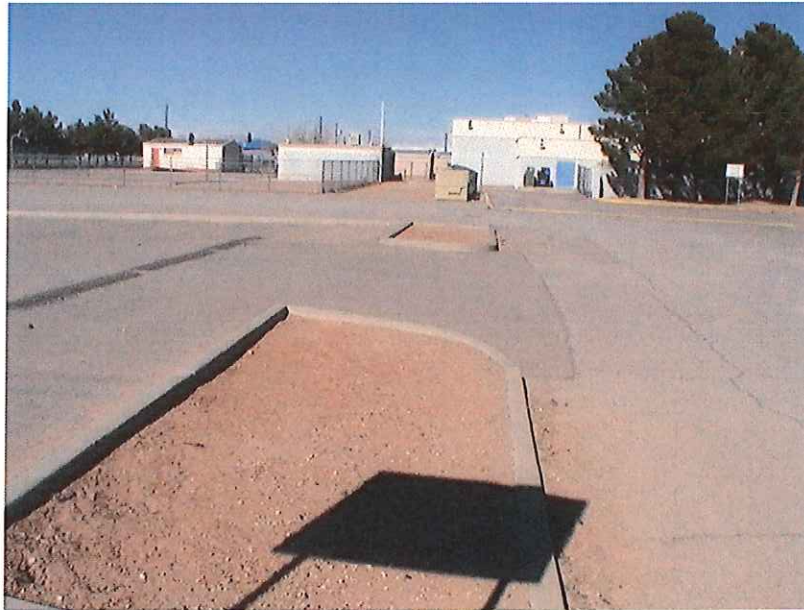
Figure 21 - Chaparral ES Faculty Parking

The adjacent Faculty parking area west of the main entrance / exit is in fair condition and appears to have been added after the main school was constructed. A regular maintenance and sweeping schedule to remove the sand and debris from the storm water flow paths is needed. The existing pavement receives light vehicle traffic and the expected

useful life can be extended by applying a 1" asphalt surface overlay or pavement preservation treatment within the next 2 to 4 years.

- Faculty Parking – Fair Condition – Pavement preservation treatment within 2 to 4 years.

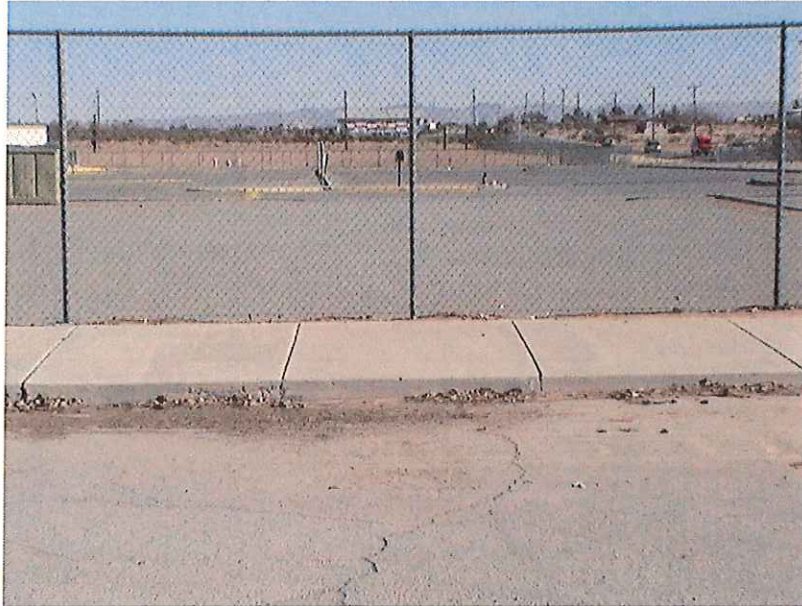
Figure 22 - Chaparral ES Gravel Parking

The other gravel parking area is also used for overflow parking due to the high volume of traffic the main parking area experiences. In order to better serve the facility, this gravel surface parking could be paved with curb & gutter and sidewalks constructed to relieve some of the congestion to the pavement for the main entrance and in turn help extend the life of main parking pavement. It is recommended to pave the gravel parking and include a designated and separate trash dumpster pick up area that will utilize reinforced concrete dumpster pads with either concrete paving or thickened asphalt paving up to and directly in front of the dumpsters. This would ensure that the direct loading from heavy trucks would be confined to the thickened wear surface or concrete pad and would alleviate any settling and cracking on less rigid wear surfacing. It is recommended to complete this work within the next 2 to 4 years.

- Pave existing gravel parking area

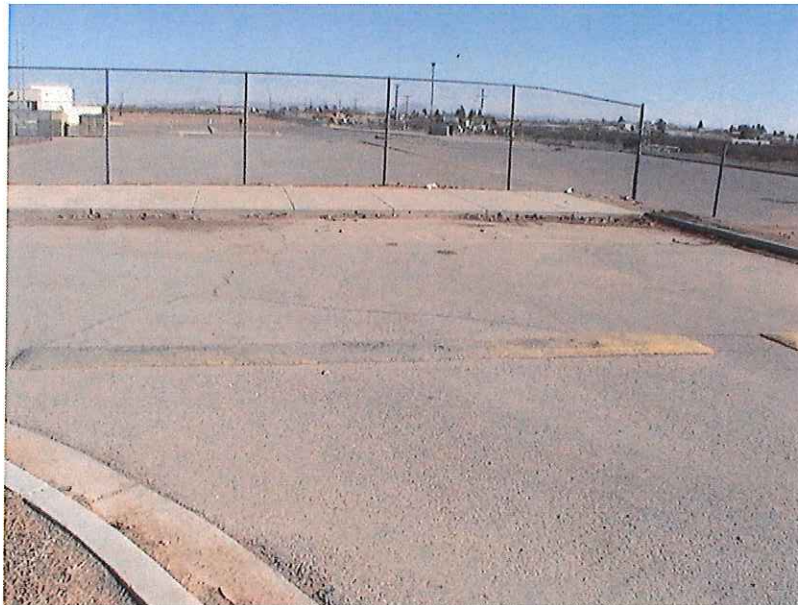
Figure 23 - Chaparral ES Bus Drop Off

The Bus Drop Off also appears to have been added after the original school construction and is fair condition. It was noted that there were some longitudinal and transverse cracking throughout the driving surface. The overall surface appeared to be in fair condition with 1" asphalt surface overlay or crack sealing and pavement preservation treatment recommended within the next 2 to 4 years. A 1" asphalt overlay could replace the pavement preservation treatment for this section and would greatly extend the expected useful life of the surface. Restriping and marking would be required upon completion.

- Bus Drop Off – Fair Condition – Crack repair and Pavement preservation treatment or 1" asphalt overlay within 2 to 4 years.
