GADSDEN INDEPENDENT SCHOOL DISTRICT

PAVEMENT ANALYSIS REPORT

RIVERSIDE, SUNLAND PARK, DESERT VIEW

FEBRUARY 8, 2012

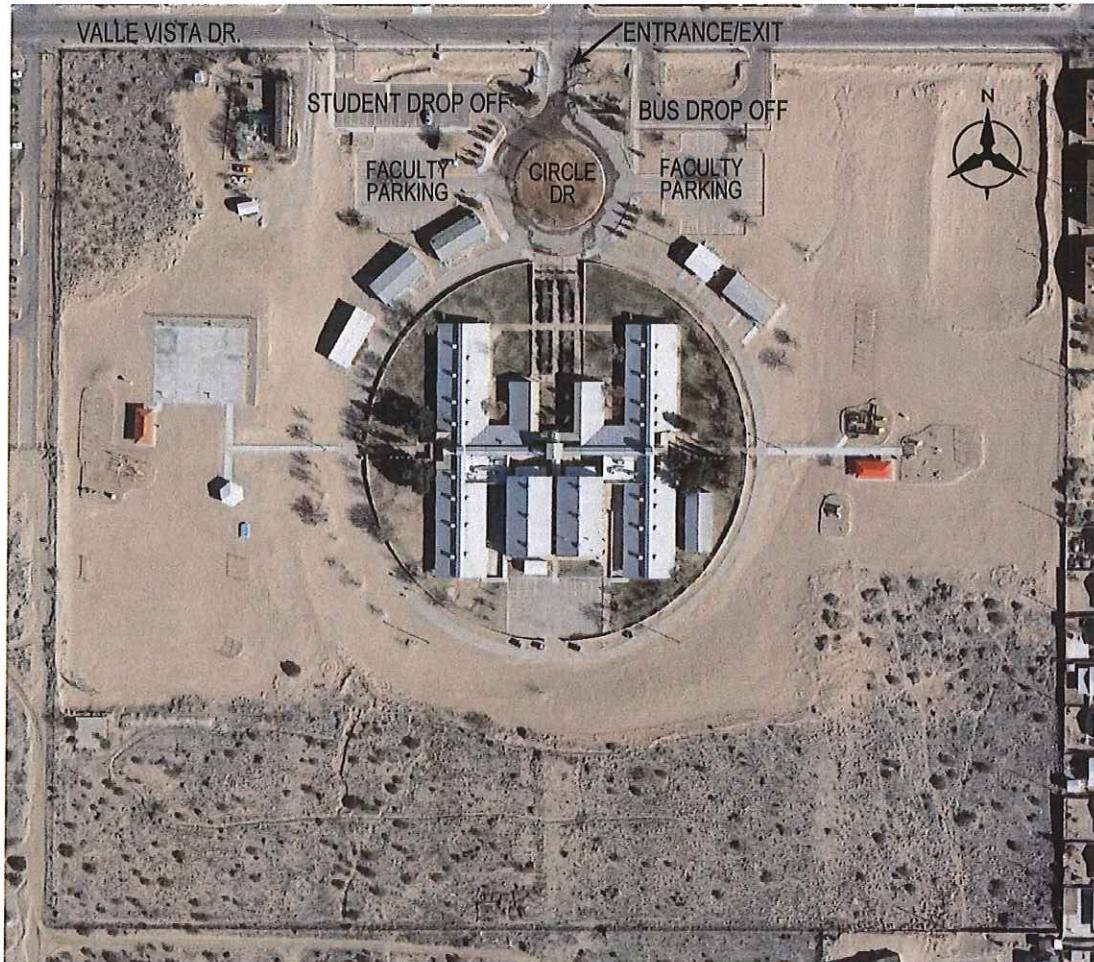
Figure 1 – Desert View Elementary School

The main circle drive entrance to Desert View appears to be part of the original construction of the school building and is showing signs of disintegration and wear. Raveling and weathering of the pavement is evident by a rough jagged pavement surface. Pavement aggregate polishing is also apparent and is due to prolonged traffic use over the surface. The turn out to Valle Vista Dr. shows the most extensive surface damage with various potholes and repairs. This portion of asphalt paving has reached the extent of its expected useful life and will require complete removal and replacement of the asphalt surface.

The Faculty and Parent/Visitor parking lots east and west of the circle drive show less wear than the main circle drive, but do exhibit signs of raveling and weathering. Much of the asphalt binder has been lost over the years and reveals a rough aggregate finish. Typically these two parking areas only experience light vehicle traffic with only limited heavy truck traffic. A 1" asphalt surface overlay would extend the useful life cycle by 8 to 10 years or a crack repair and a pavement preservation slurry seal treatment could be used to extend it 6 to 8 years. The 1" asphalt surface overlay would provide extended useful life and overall

The bus drop off to the east of the main circle drive is relatively new and is in good condition. Removal of the accumulation of sand and debris from the concrete gutter pans is needed and a regular schedule of general sweeping and cleaning of all drainage paths should be implemented in the school maintenance program. A pavement preservation slurry treatment within the next 6 to 8 years is recommended.

The student drop off on the west side is also new and in good condition. Typical sand and debris removal along the gutter pans and drainage paths is also recommended. A pavement preservation slurry treatment within the next 6 to 8 years will extend the pavement life cycle. Associated curb and gutters, sidewalks, ramps and drainage structures appeared in good condition and only regular cleaning is required. New striping and marking will be required after any pavement preservation treatment is completed.

improved performance. However the crack repair and pavement preservation treatment would be recommended as a minimum maintenance objective.

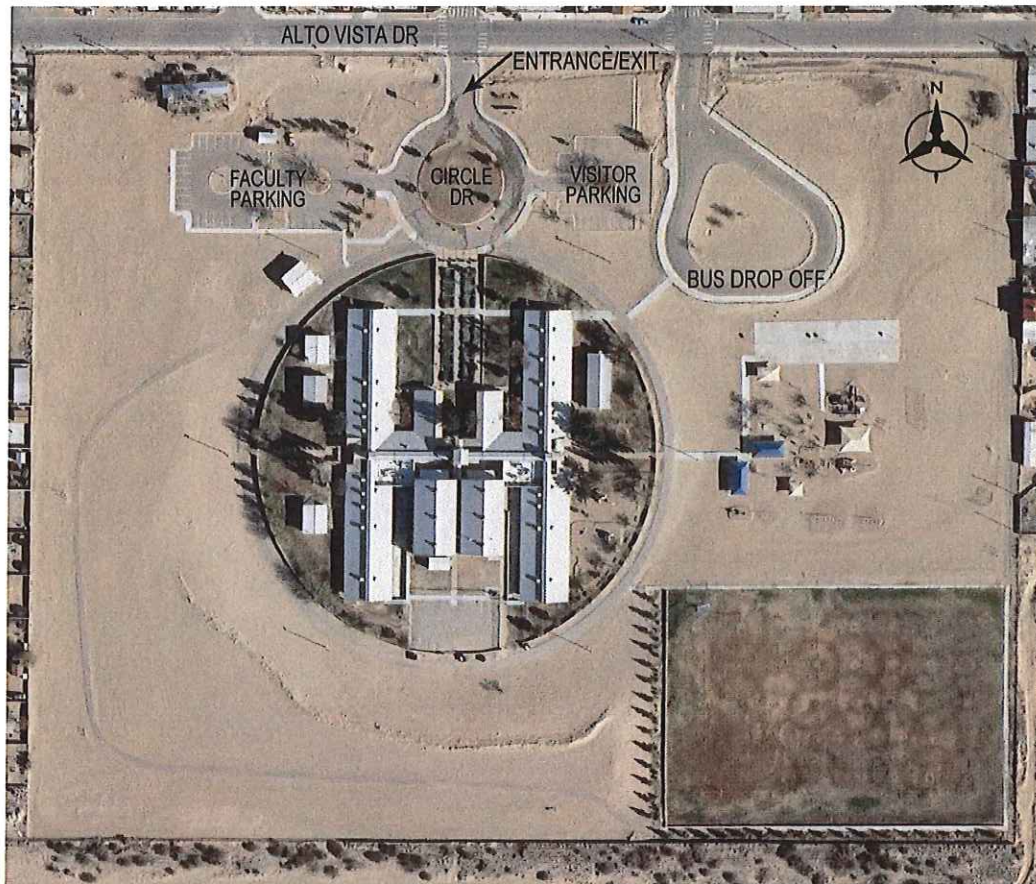
Figure 7 – Sunland Park Elementary School

The Main Circle Drive entrance is in poor condition and is weathered and raveled extensively. Many pothole and patches are apparent throughout the driving surface, as are ruts and large deposits of fine sand particles and debris. A pavement section located at the main entrance, from Alto Vista Drive to the apparent right of way will require complete removal and replacement as soon as funding allows.

The Parent/ Visitor parking to the east is also weathered and has lost a major portion of binder material which has left portions of the aggregate exposed. There were no signs of major cracking or asphalt displacement, which would indicate the underlying substrate material is in good condition. Due to the relative light traffic this parking lot experiences, a complete removal and replacement could be delayed by a 1" asphalt surface overlay or pavement preservation slurry treatment. As with the other schools, the 1" overlay option would greatly extend the service life of the parking lot, but may not be financially feasible

The Faculty parking area west of the circle drive also appears to be original to the school building and appears to experience much of the same wear that the parent / visitor parking area has. The binder material has disintegrated over the years and left a rough pavement surface. There are some areas of pothole patches, but no major longitudinal cracking is evident. With a general sand and debris removal program implemented, the expected useful life can be extended with a pavement preservation slurry applied within the next 4 to 6 years. The expansion of the faculty parking area that was complete in 2004 is in good condition and no immediate action is required. Pavement preservation slurry should be scheduled within the next 8 to 10 years.

The separate Bus Drop Off east of the main entrance is in good condition, with the exception of accumulation of fine sand particles. General pavement sweeping of the top surface and along the curb line will allow for appropriate drainage flow patterns and improve general appearance. A pavement preservation treatment should be scheduled within the next 6 to 8 years to extend the pavement performance.

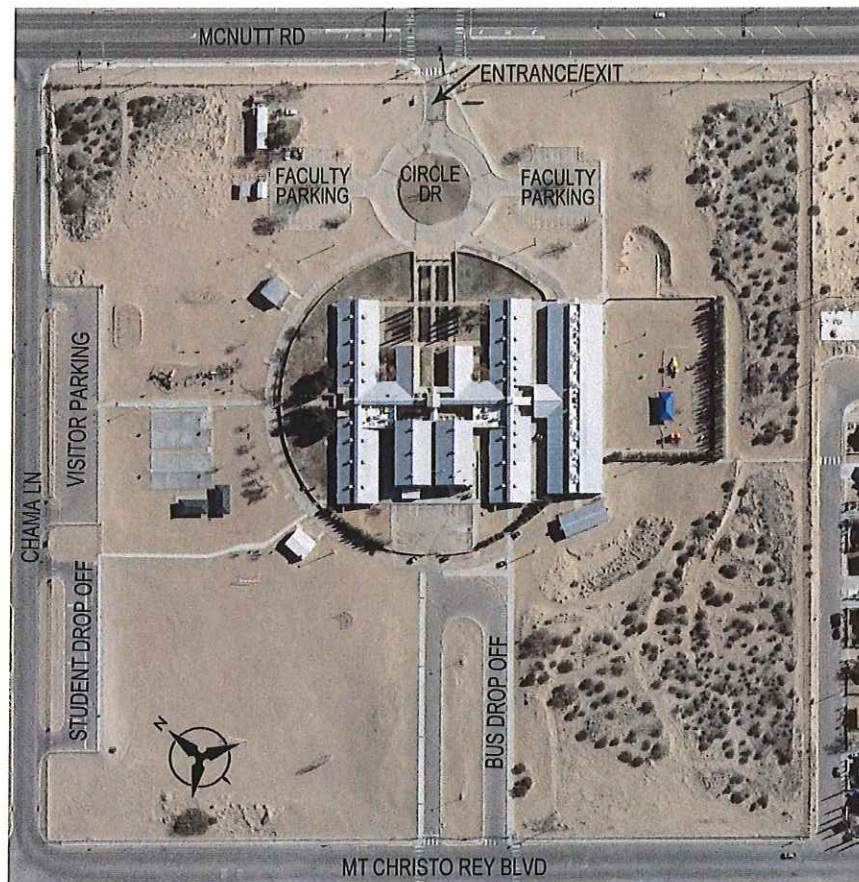
Figure 13 – Riverside Elementary School

The Main Circle Drive entrance pavement surface is deteriorated and has many potholes and large areas of pavement patches throughout. Longitudinal cracks are prevalent throughout the circle drive as well loss of much of the asphalt binder material. The entrance to the circle drive should be scheduled for complete removal and replacement. Additional cost will need to be anticipated for some rework of the substrate base course material and the replacement of traffic signal sensors at the McNutt and Main Circle drive intersection. The remaining pavement surface of the Circle Drive would benefit

The adjacent Visitor and Faculty parking areas are in similar condition with loss of asphalt binder material, weathering and longitudinal cracking. However, due to the limited use of these parking areas, complete removal and replacement could be delayed by a 1" asphalt surface overlay or crack sealing and pavement preservation slurry treatment. If either option is applied within the next 2 to 4 years, the complete removal and replacement could be extended by 8 to 10.

The additional Parent / Visitor parking area which is accessed from Chama Lane, was constructed in January of 2006 and is in good condition, with the exception of fine sand particles and minor debris. As a preventative measure, pavement preservation slurry within 6 to 8 years should be scheduled.

A new Parent / Student Drop Off was also constructed in 2006 and remains in good condition. As with the adjacent Visitor Parking area, the new Student Drop Off should be scheduled for a pavement preservation slurry treatment and restriping within the next 6 to 8 years.

The Bus Drop off at the rear of the property fronting Mt. Cristo Rey Blvd. is also relatively new and is in good condition with only typical sweeping and maintenance required. Pavement preservation slurry should be scheduled within 4 to 6 years to prolong its useful life.

from a 1" asphalt surface overlay to extend the service life of the pavement. A replacement and overlay time frame would be expected to be to be completed within the next 2 to 4 years.

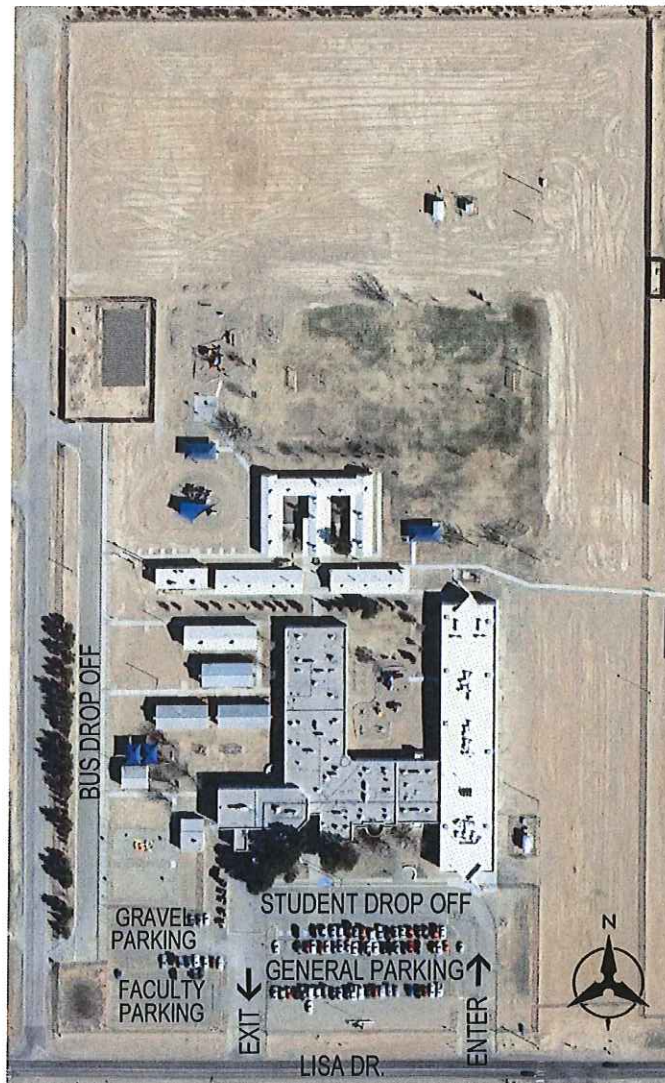
Figure 18 – Chaparral Elementary School

The Main parking and parent student drop off is in a dilapidated state with many longitudinal and transverse cracks throughout. As expected for the age of the asphalt pavement, much of the binder material has been lost over time and the driving surface is rough and worn with ruts and surface disintegration. The main access from Lisa Drive is in very poor condition and is in need of immediate repair. Large potholes and broken pavement sections impede traffic to and from the facility and should be a priority for complete replacement. The asphalt curb on the east end of the parking lot is broken with various sections missing in many areas along its length. Potholes and temporary repairs are also evident throughout the pavement surface. It is recommended that the entire parking surface be removed and replaced. Additional installation of curb and gutters, as well as sidewalks should be included as part of the overall project. This parking facility is generally

The adjacent Faculty parking area west of the main entrance / exit is in fair condition and appears to have been added after the main school was constructed. A regular maintenance and sweeping schedule to remove the sand and debris from the storm water flow paths is needed. The existing pavement receives light vehicle traffic and the expected

The other gravel parking area is also used for overflow parking due to the high volume of traffic the main parking area experiences. In order to better serve the facility, this gravel surface parking could be paved with curb & gutter and sidewalks constructed to relieve some of the congestion to the pavement for the main entrance and in turn help extend the life of main parking pavement. It is recommended to pave the gravel parking and include a designated and separate trash dumpster pick up area that will utilize reinforced concrete dumpster pads with either concrete paving or thickened asphalt paving up to and directly in front of the dumpsters. This would ensure that the direct loading from heavy trucks would be confined to the thickened wear surface or concrete pad and would alleviate any settling and cracking on less rigid wear surfacing. It is recommended to complete this work within the next 2 to 4 years.

inadequate to handle the current volume of traffic and additional parking should be considered. The overall condition of this parking facility warrants complete removal and replacement as soon as practical for the District.
